ADDENDUM NO. 2

Date: October 3, 2018
Project: **MARINWOOD-HWY 101 TRUNK SEWER UNDERCROSSING
EMERGENCY REPAIR**
Job No.: **11200-03**
To: All Planholders and Prospective Bidders

Las Gallinas Valley Sanitary District
 Sewer Trunk Video Inspection
 Various Locations

1.2	Location	Marinwood-Lucas Valley Trunk	Diameter	18"	TV'd Ftg	417'
	Upstream MH	M000.51	Material	CMP	Total Ftg	417'
	Downstream MH	M000.49	Direction	DS

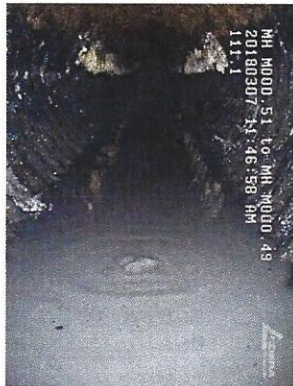
111' I/I under flow

Summary:	Corrugated pipe severely corroded however no deformations noted.
Recommendation:	Remove grease, seal active infiltration. Install Dynaliner PVC Thermoformed SDR35 Liner.

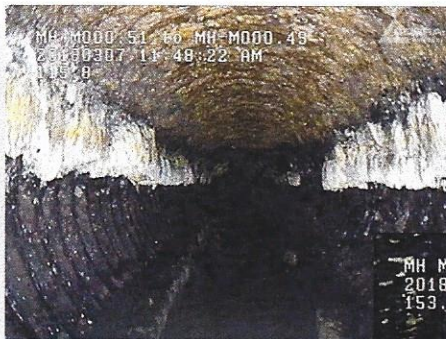
119' Grease

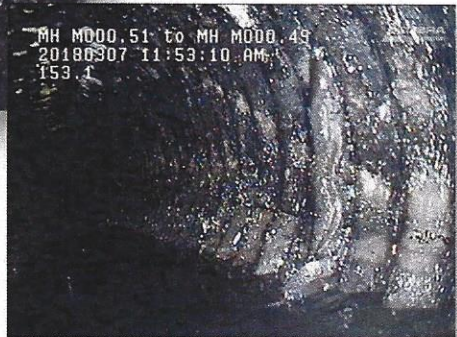
153' Faulty joint seal

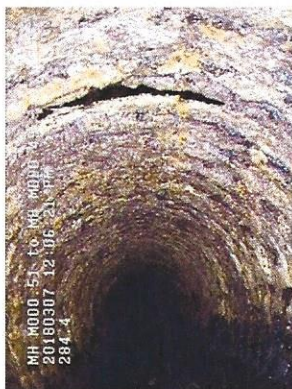
Holes in pipe wall at 246' & 284'

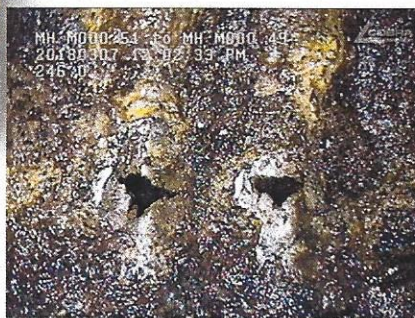
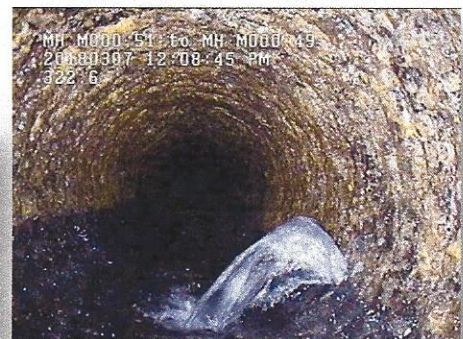
~~322~~ I/I gusher
